TECHNICAL BULLETIN

REF NO:	3005
DATE:	APRIL 25, 1991
ENG:	JOHN LYNCH
PAGE:	1 of 1

TO: ALL REGIONAL OFFICES AND FIELD SERVICE ENGINEERS
 PRODUCT: 9 SERIES COLOR MONITORS -- TM14-9RH AND TM20-9RH

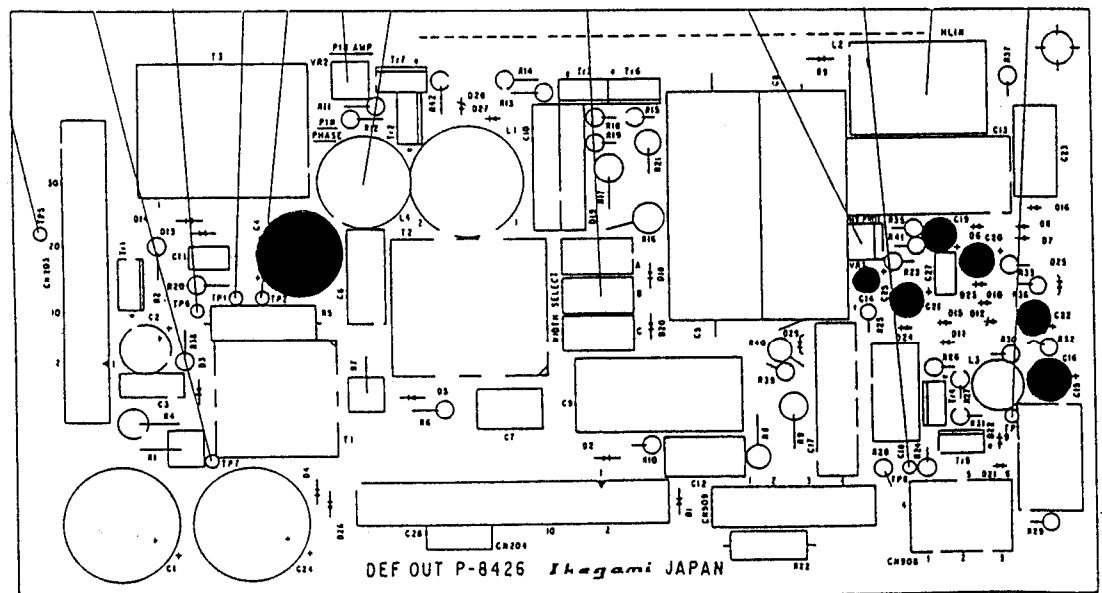
SYMPTOM: MONITOR SHUT DOWN OR NO HIGH VOLTAGE.

CAUSE: AFTER YEARS OF OPERATION SOME CAPACITORS DRY UP DUE TO HEAT AND CAN CHANGE IN VALUE, AFFECTING THE MONITORS PROTECTION CIRCUITRY AND TURNING OFF THE HIGH VOLTAGE DRIVE.

C4, C16, C19, C20, C21, C22 and C25.

SOLUTION: CHANGE THE ELECTROLITIC CAPICATORS ON THE DEFLECTION OUTPUT MODULE, THOSE WHICH MAY NEED REPLACEMENT ARE:

PART NUMBERS AND LOCATION ARE SHOWN BELOW.
