# TECHNICAL BULLETIN

Date: Oct. 31, 2007  
Engineer: Larry Cuccio  
Page: 1 of 2

Product: VFL-900HD Viewfinder

Symptom: No operation due to blown fuse

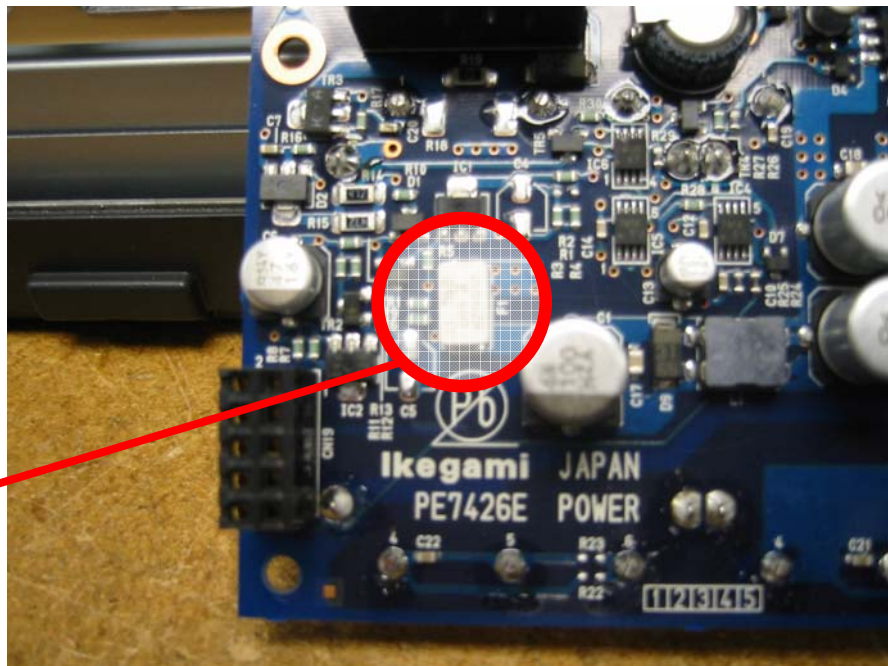
FIGURE 2

When the viewfinder is turned on, the surge current may be high enough to cause the fast-acting fuse, F1, to open. To correct this problem, it is recommended to change F1 to a Slo Blo type fuse.

FUSE F1

1. On the back of the viewfinder, remove the connector cover, then remove the interconnect cable.
2. Remove the 5 screws holding the rear cover in place. ( 2 top, 2 bottom, 1 by the connector cover.
3. Remove the power module (4 screws). This module has a red heat sink on it. Refer to Fig. 1.
4. Remove Fuse F1, located on the component side of the power module. This component is located on the left side of the board. Refer to Fig. 2
5. Replace with a 2.5A Slo Blo fuse.
6. Reinstall the power module, rear cover, interconnect cable, and connector cover.

Fuse, 2.5A Slo Blo, P/N 046002.5VR
