# TECHNICAL BULLETIN

Date: Feb. 20, 2008  
Engineer: Larry Cuccio  
Page: 1 of 4

To: Distribution  
Product: TM9-1 Color Video Monitor  
Symptom: Vertical Deflection Problem

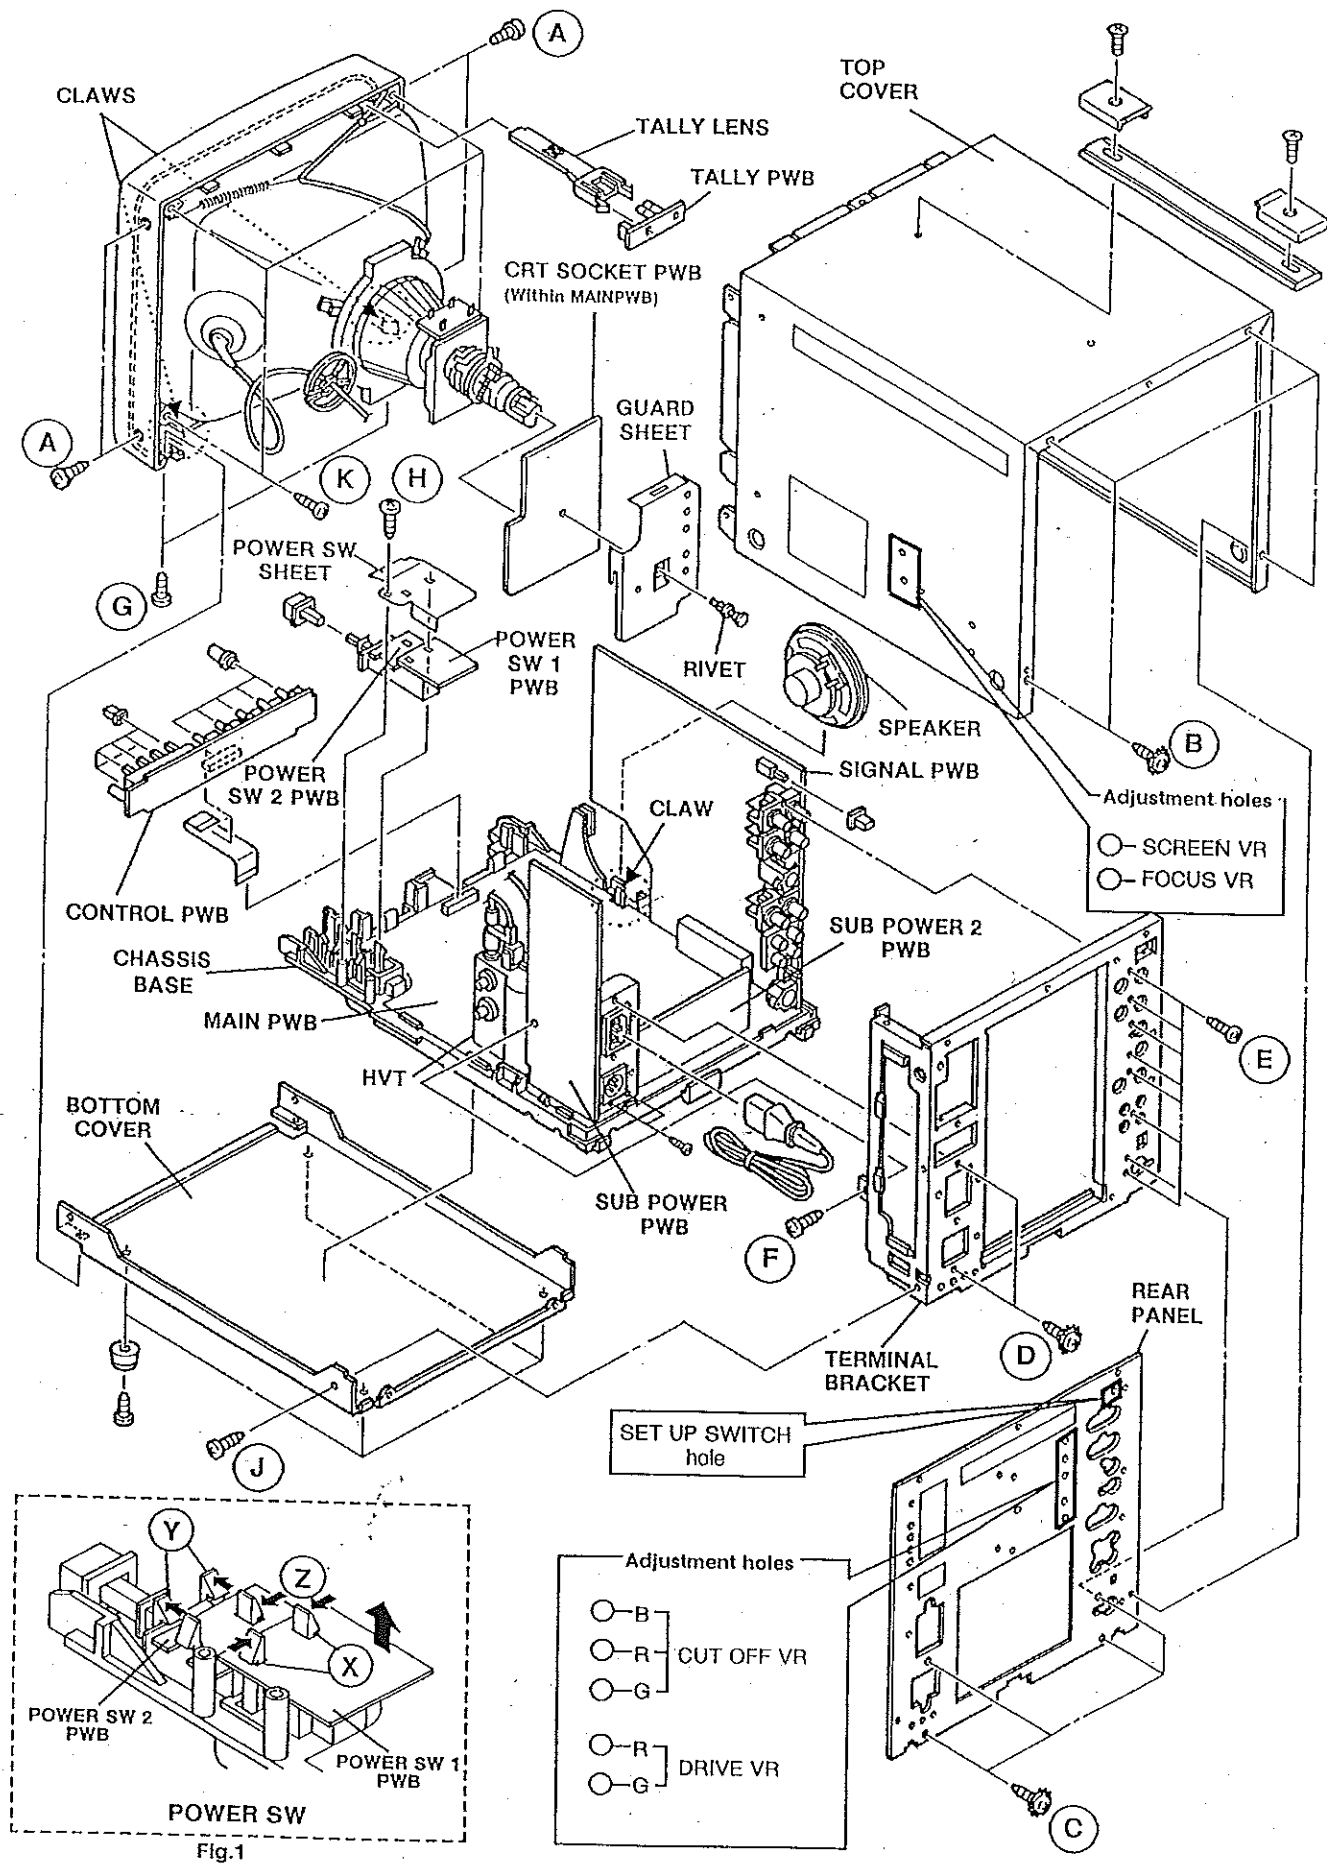
Fig.1

Capacitor C416 on the Main PWB may breakdown, causing a vertical deflection failure and loss of picture. The capacitor has reached the end of its life and must be replaced.

1. The exploded view diagram (Fig. 1) will show the location of the Main PWB, which must be removed for access to C416.
2. Remove C416. Refer to Fig. 2 for location.
3. Replace C416 with a new capacitor.
