SE-79HD System Expander

Loss of vertical sync in video in the LCD Viewfinder

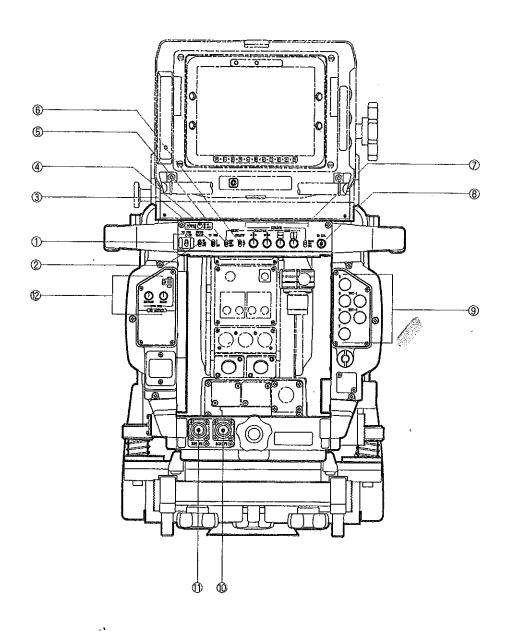
- 1. Remove the video board. It is located in the rear of the system expander, on the left side behind the panel with the VF aspect control and tally light. Loosen three screws to remove this panel. (Refer to Fig. 1, control location 12, for panel location).
- 2. Remove resistors R527 and R554. Refer to Fig. 2 for their location.
- 3. Replace with 15K ohm resistors.

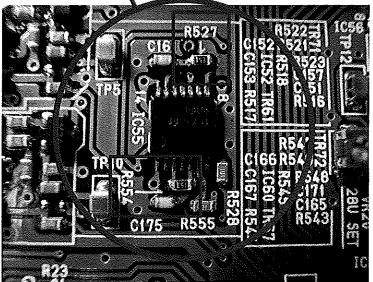
Fig 2

To upgrade the SE-79D System Expander to accept all formats, a new multi-format Video Board is installed. Occasionally, a problem can occur where vertical sync is lost in the VF video, resulting in an unstable, rolling image. This problem occurs only in the multi-format video board with PCB # PE6411E. To correct this problem, two resistors, R527 (33K ohm) and R554 (33K ohm) will need to be changed to 15K ohm values.

Resistor, 15K ohm, P/N RGC1/16C 153D
