TECHNICAL BULLETIN

Product: HDK-79EC / HDK-79E / HDK-725P / HDK-720P

Symptom: Ret Switch pushbutton function on the handle cover is stuck on

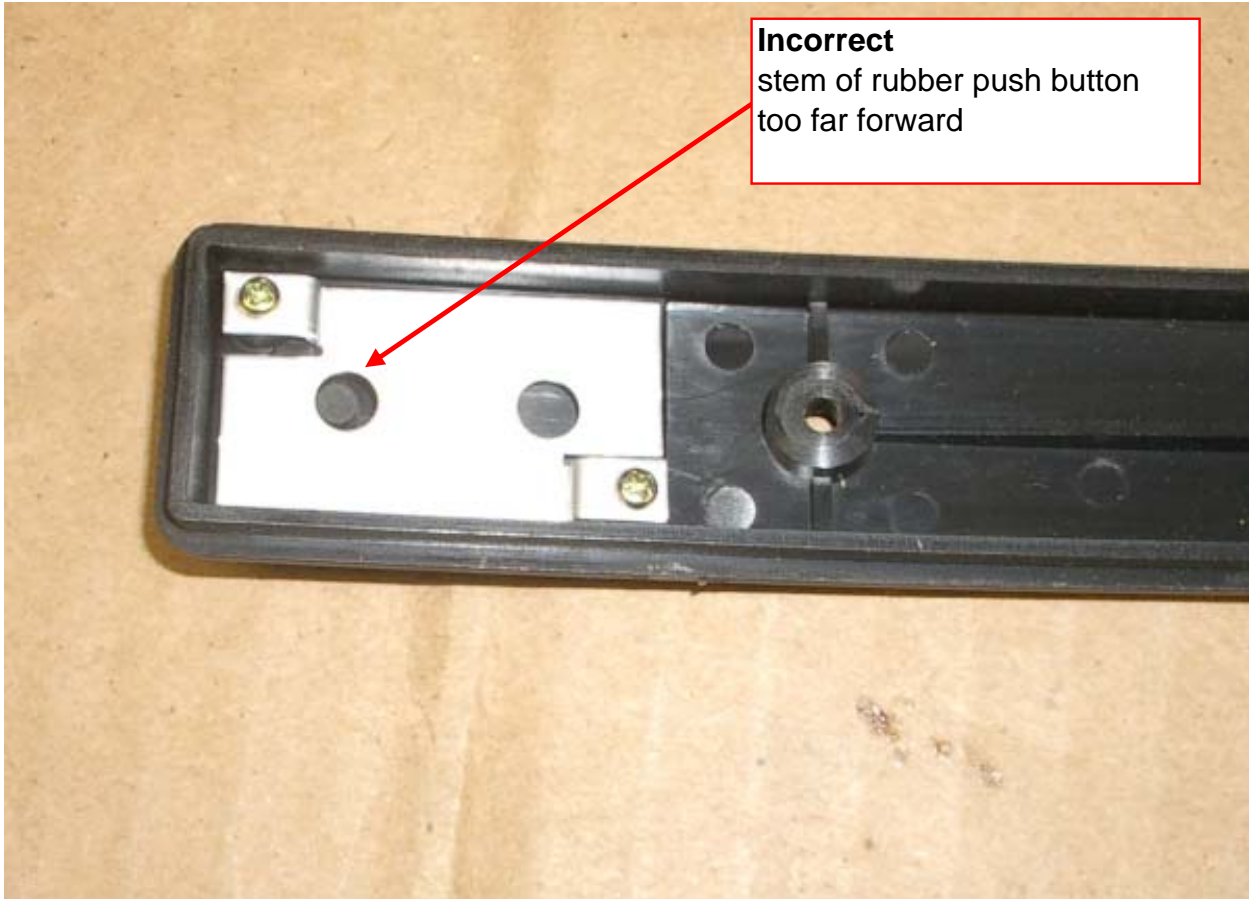
This problem can occur when the handle cover and/or the Ret Button is replaced. The Ret Switch Bracket holds the Ret Button in place. This bracket must be positioned and fastened in the correct orientation, or the stem of the push button will be too far forward and bind against the bracket, causing the Ret function to be activated continuously.

Incorrect
stem of rubber push button
too far forward

Refer to the photographs on the next page for the correct positioning of the bracket. If incorrect, remove the two screws, rotate the bracket 180°, and reattach with the screws.

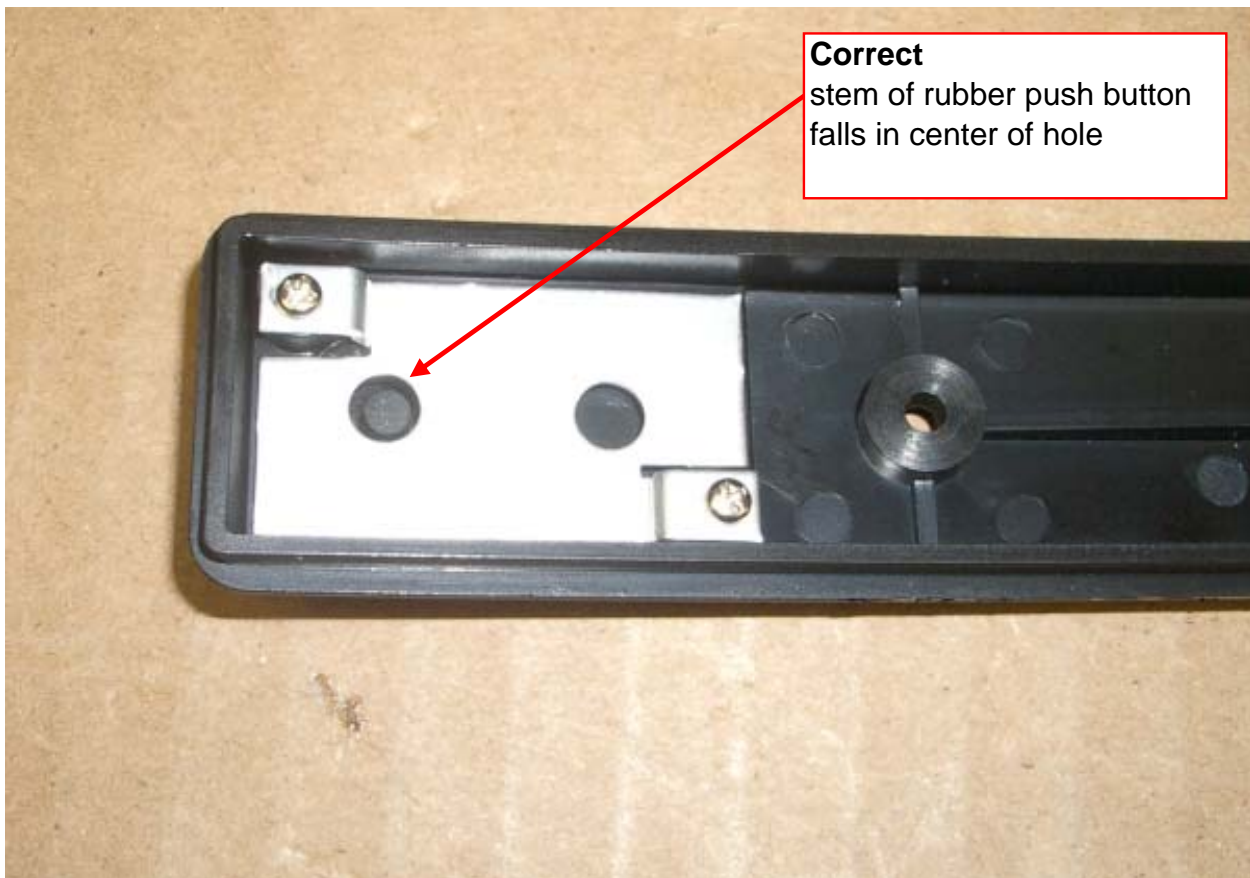
Correct
stem of rubber push button
falls in center of hole
