TECHNICAL BULLETIN

Product: BS-98

Symptom: Intermittent loss of SDI outputs, even though the diagnostics show all normal.

Purpose: Improve the range of oscillator lock especially when operating in the 720p/59.94 format by changing the value of two resistors as follows:

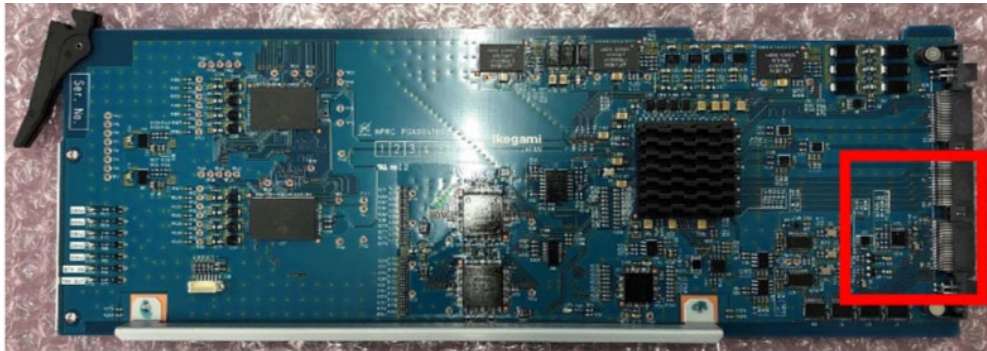
- 1) Power down, loosen 2 screws and release hinge to remove the front cover.
- 2) Carefully pull out the H_PRC board.
- 3) Locate R209, 2.2 K Ω , as indicated in the photos below.

- 4) Remove R209 and replace with a new 100 Ω resistor by soldering.
- 5) Insert the H_PRC board back into the BS-98.

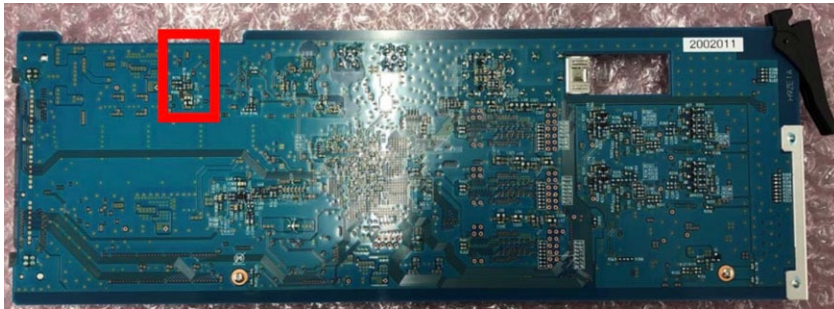
- 6) Next, carefully pull out the OPT board halfway and disconnect the LC optical connectors (#1 & #2) as shown in photo. Make sure the surface of the fiber connectors is not touched and remains clean. If available, use protective covers on the fiber connectors during the modification session.
- 7) Locate R178 as indicated in the photos below.

- 8) Remove R178 and replace with a new 100 Ω resistor by soldering.
- 9) Insert the OPT board back into the BS-98. Make sure both LC fiber connectors are connected correctly into the SFP module.
- 10) Reattach the front cover.
- 11) Power the BS-98 On, and confirm it is operating correctly.
