TECHNICAL BULLETIN

Product: VFL-900HD Viewfinder

Symptom: No operation due to blown fuse

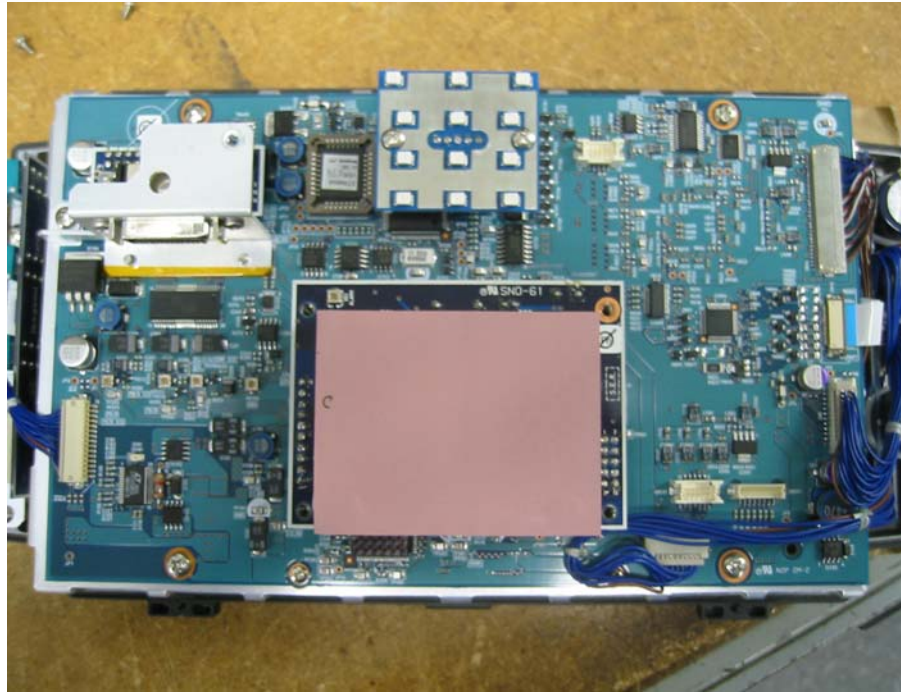
FIGURE 1

When the viewfinder is turned on, the surge current may be high enough to cause the fast-acting fuse, F1, to open. To correct this problem, it is recommended to change F1 to a Slo Blo type fuse.

1. On the back of the viewfinder, remove the connector cover, then remove the interconnect cable.
2. Remove the 5 screws holding the rear cover in place. (2 top, 2 bottom, 1 by the connector cover.
3. Remove the power module (4 screws). This module has a red heat sink on it. Refer to Fig. 1.
4. Remove Fuse F1, located on the component side of the power module. This component is located on the left side of the board. Refer to Fig. 2
5. Replace with a 2.5A Slo Blo fuse.
6. Reinstall the power module, rear cover, interconnect cable, and connector cover.
