# TECHNICAL BULLETIN

**Date:** 6/15/12  
**Engineer:** Alan Keil  
**Page:** 1 of 2

**Product:** Hi-Motion II

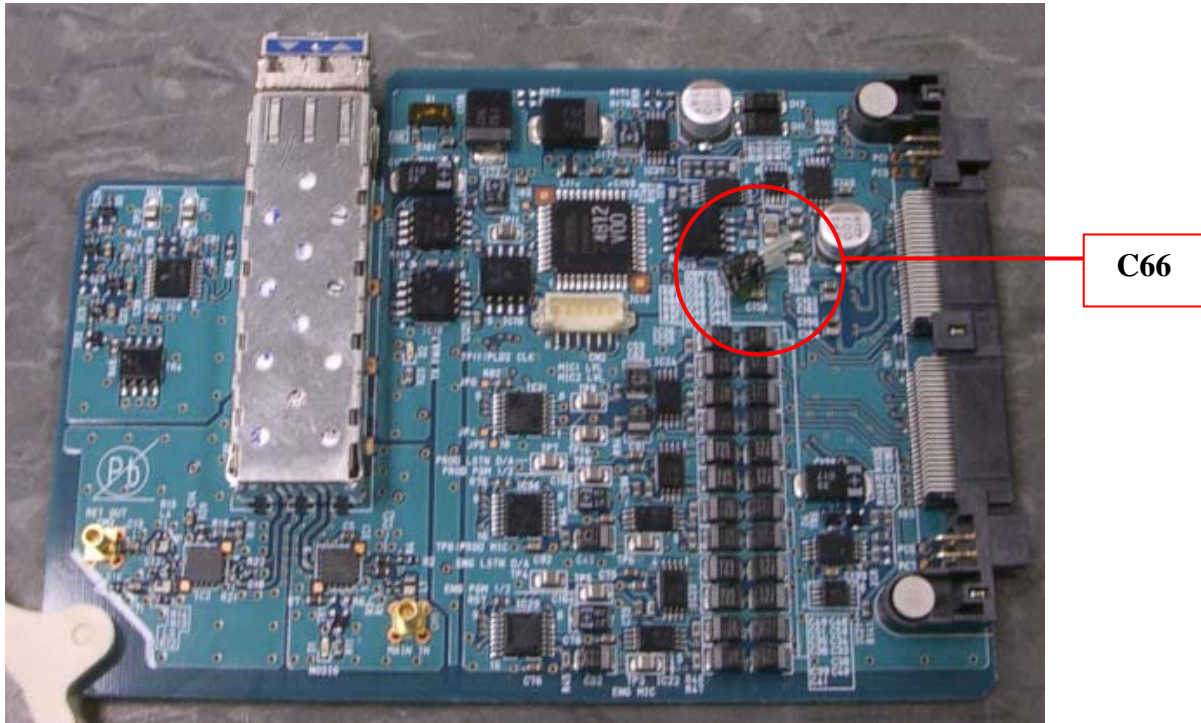
**Figure 1 – E/O & O/E board**

**Symptom:** When the camera is connected to a Telecast SHED HDX the 1K load of the HDX causes a capacitor on the E/O & O/E board to be reverse biased, which causes the voltage on one low voltage standby line to increase over time, sometimes exceeding the detection range for an Ikegami type camera. The HDX may then shut down or power cycle. This capacitor will become damaged over time, further increasing the likelihood of voltage detection errors in the HDX.

**Instruction:** Remove the E/O & O/E board taking care of the two fiber and two coax leads connecting to this board. Remove capacitor C66 (15uF/16v) and replace with a 10uF/10v bi-polar capacitor, part number UMP1A100MDD. Since the bi-polar replacement capacitor is not surface mount type, it should be mounted on its side using a silicone adhesive to maintain position. Refer to figure 1 for part location.

**Note:** lead free solder should be used for work on this pc board.
