TECHNICAL BULLETIN

Product: VF46HDE

Symptom: The viewfinder picture shrinks in vertical height over time.

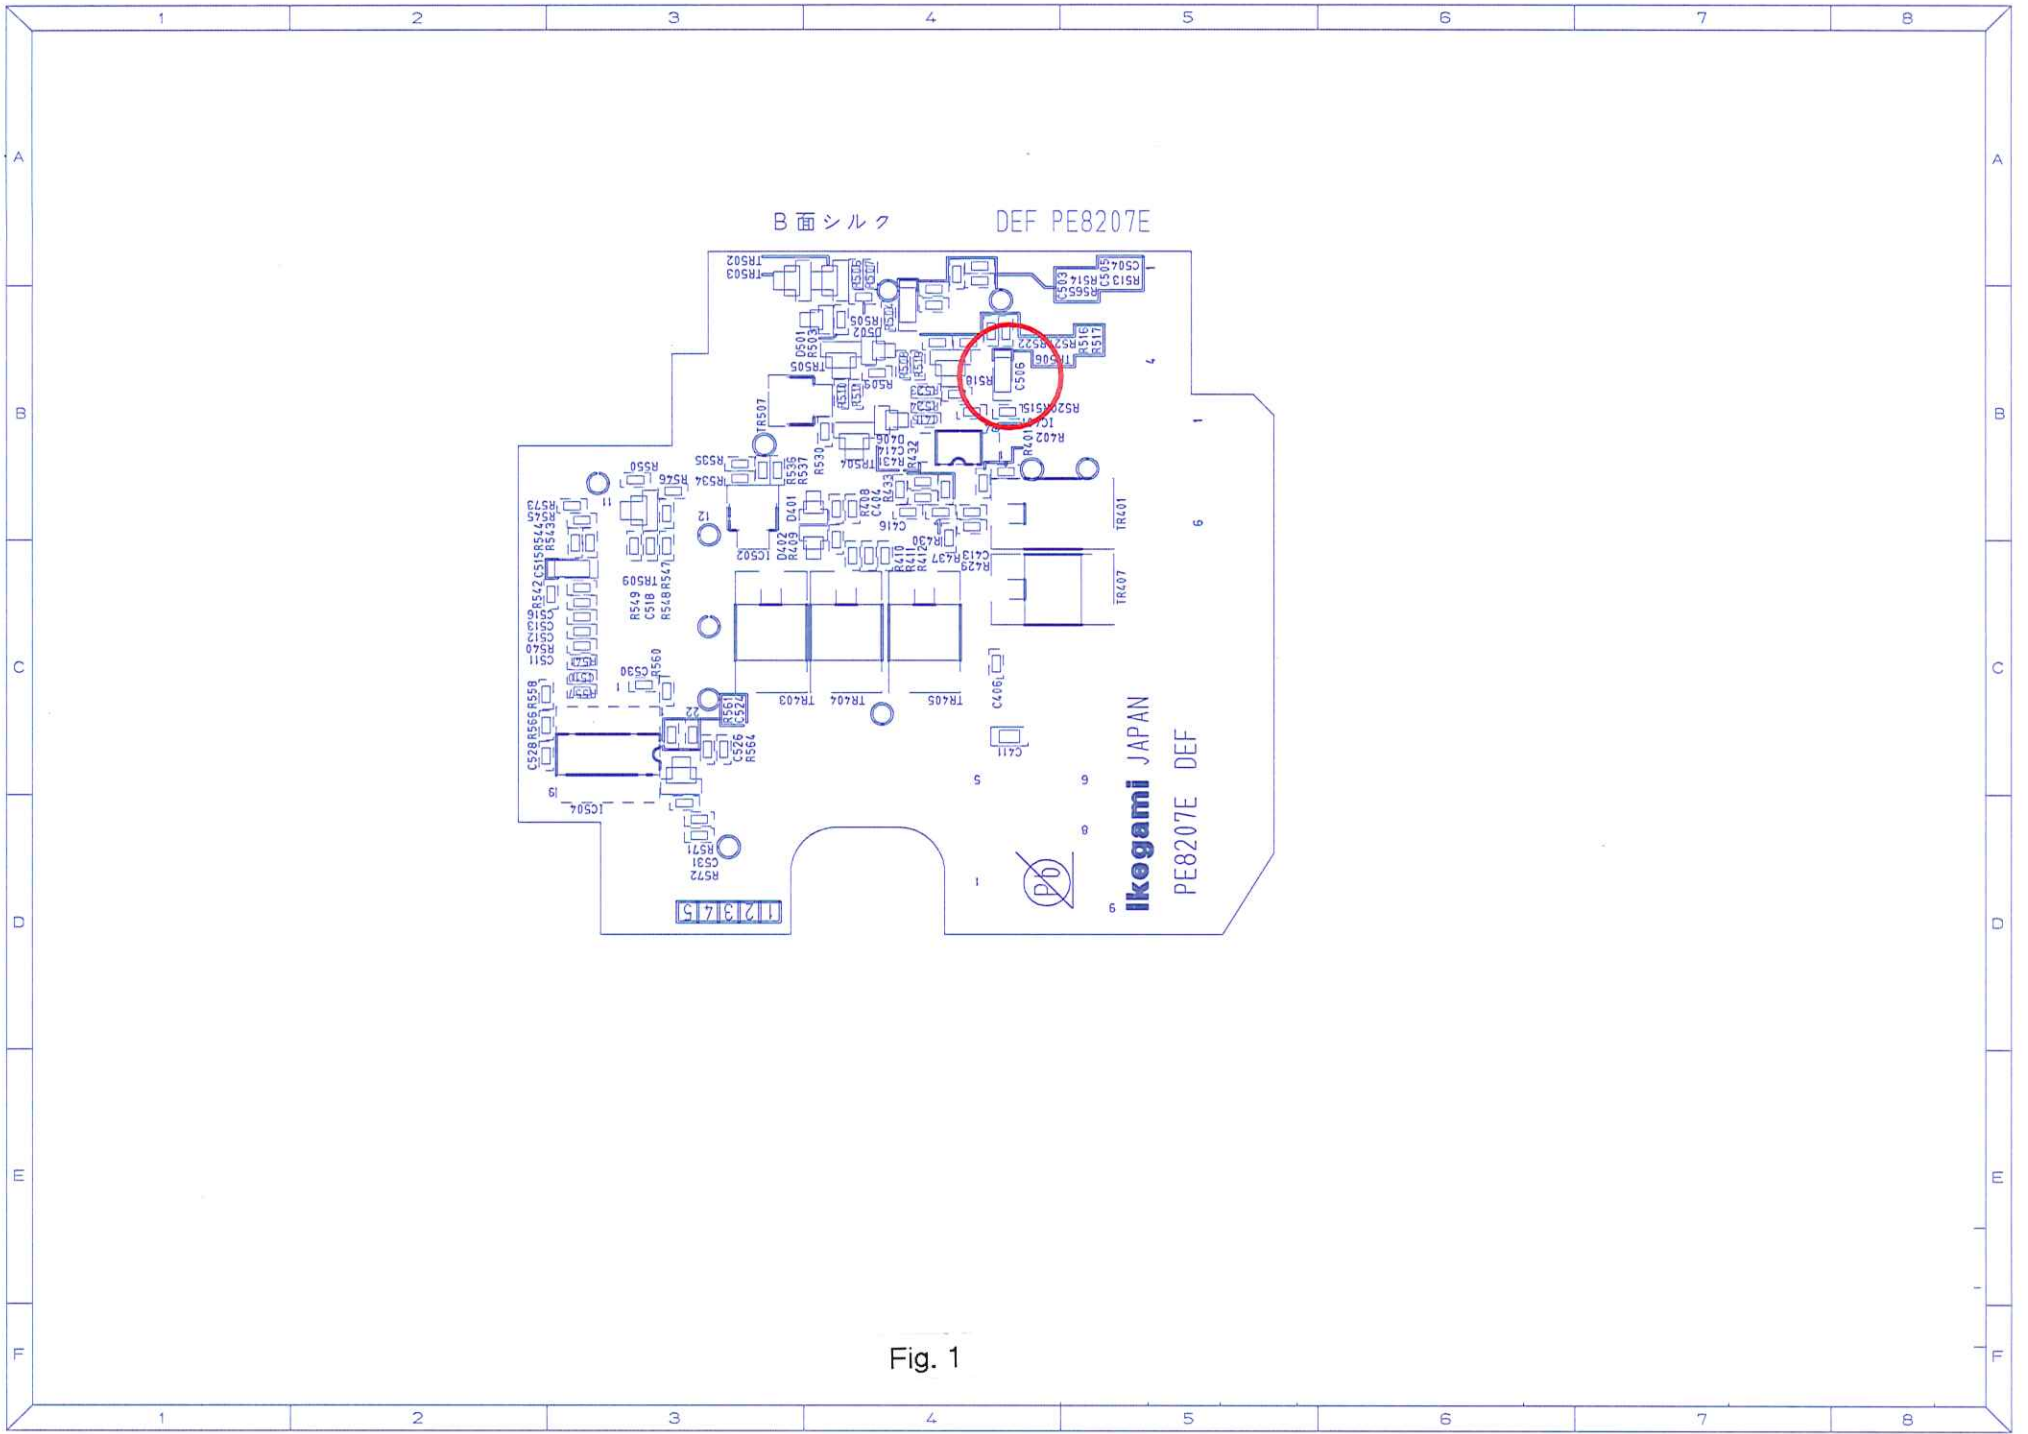
A tantalum capacitor, C506 on the DEF Board, was mounted in the wrong polar direction due to an incorrect silkscreen printing.

1. Disassemble the VF, and remove the DEF Board.
2. Locate and remove C506 (Fig.1). Note the polarity (silver band) of the capacitor, and the silk screening on the board.
3. Replace C506 with a new one, making sure that the polarity is in the opposite direction. Figs. 2 & 3 shows a corrected, current version of this board.
