IKEGAMI TECHNICAL
BULLETIN

RefNo: 101201
Date: October 12, 2001
Engineer: John Lynch
Page: 1 of 2

Product: TM 14-20 RH

Subject: RGB OUT BOARD

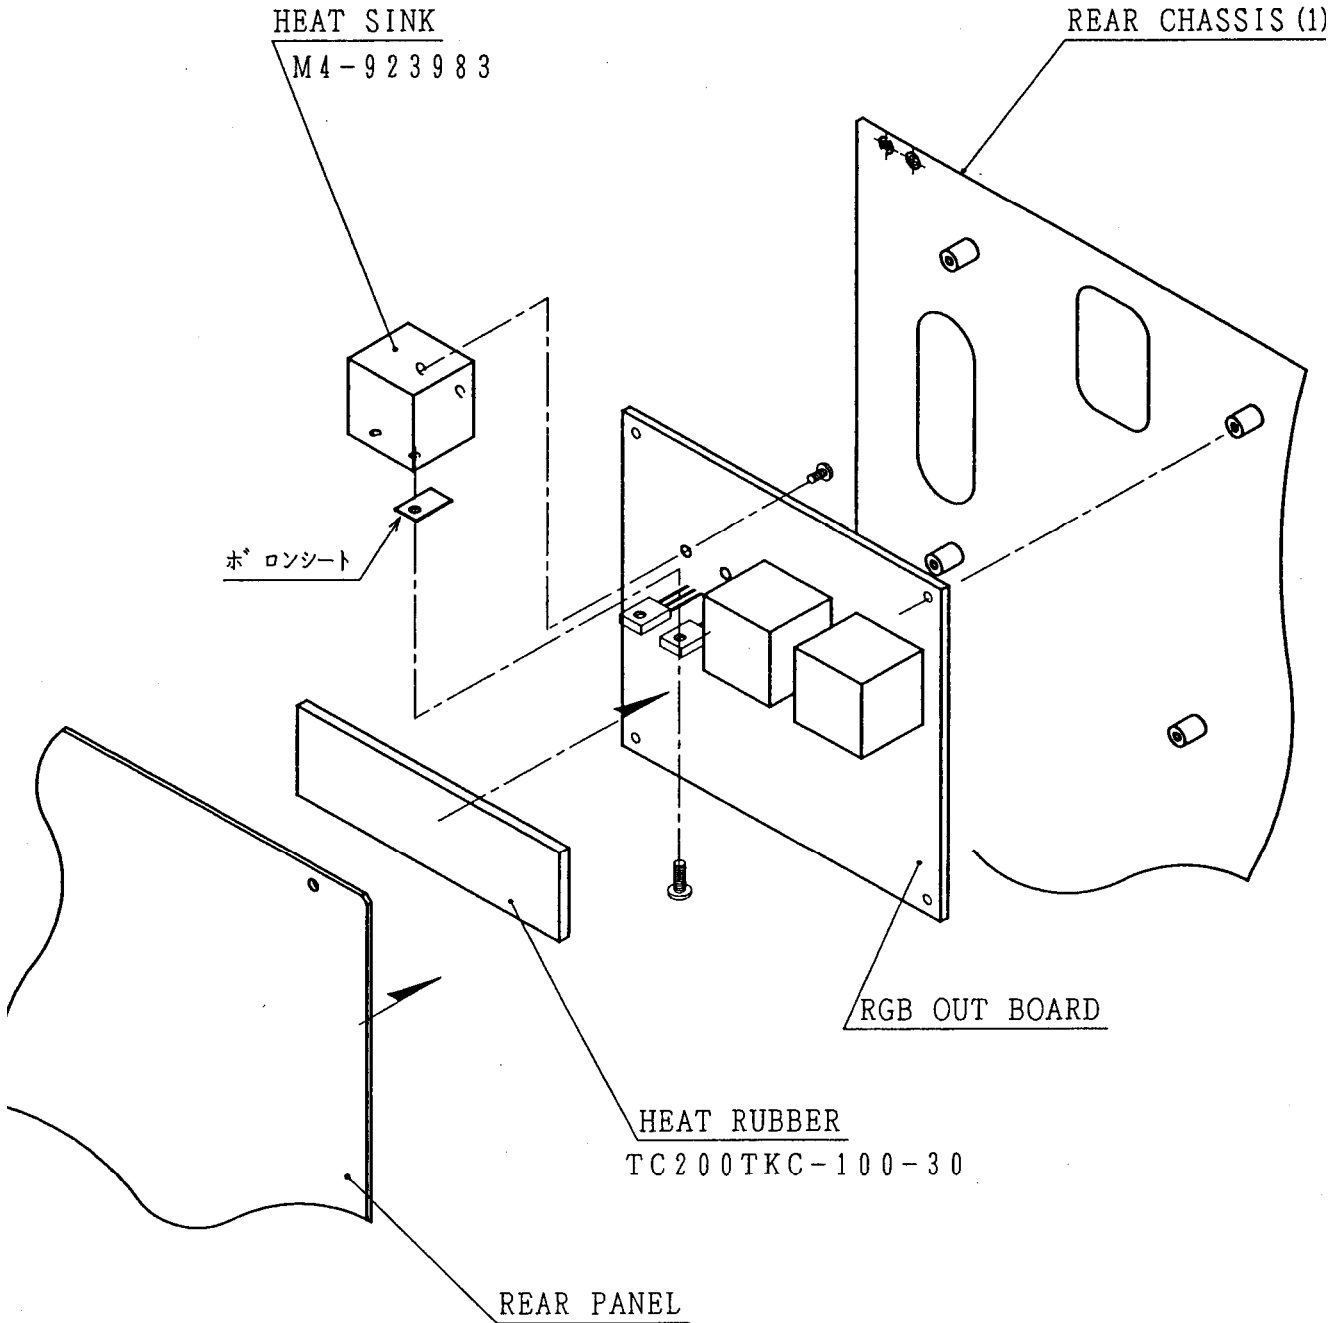
HEAT SINK
M4-923983

REAR CHASSIS (1)

ホロンシート

RGB OUT BOARD

HEAT RUBBER
TC200TKC-100-30

REAR PANEL

In the event of failure of the heat sync transistors Tr-104, 204, 304 type-2SA1407E and / or Tr-105, 205, 305 type-2SC3601E. It is recommended to change the heat sync method with the " kit " outlined in this bulletin, procedure as follows:

1. Remove the RGB OUT board from rear of monitor.
2. Remove the six old heat sync's.
3. Replace the 6 transistors as necessary. (Caution 2 types)
4. Install the three new heat sync's per attached drawing.
5. Place the white pad's between transistors and heat sync.
6. Screw the transistors to heat sync and heat sync to PC board.
7. Add the heat sync rubber. (stick to heat sync's)
8. Install the RGB OUT board in the rear of monitor.
