# TECHNICAL BULLETIN

Date: Feb. 20, 2008  
Engineer: Larry Cuccio  
Page: 1 of 4

To: Distribution  
Product: TM9-1 Color Video Monitor  
Symptom: Vertical Deflection Problem

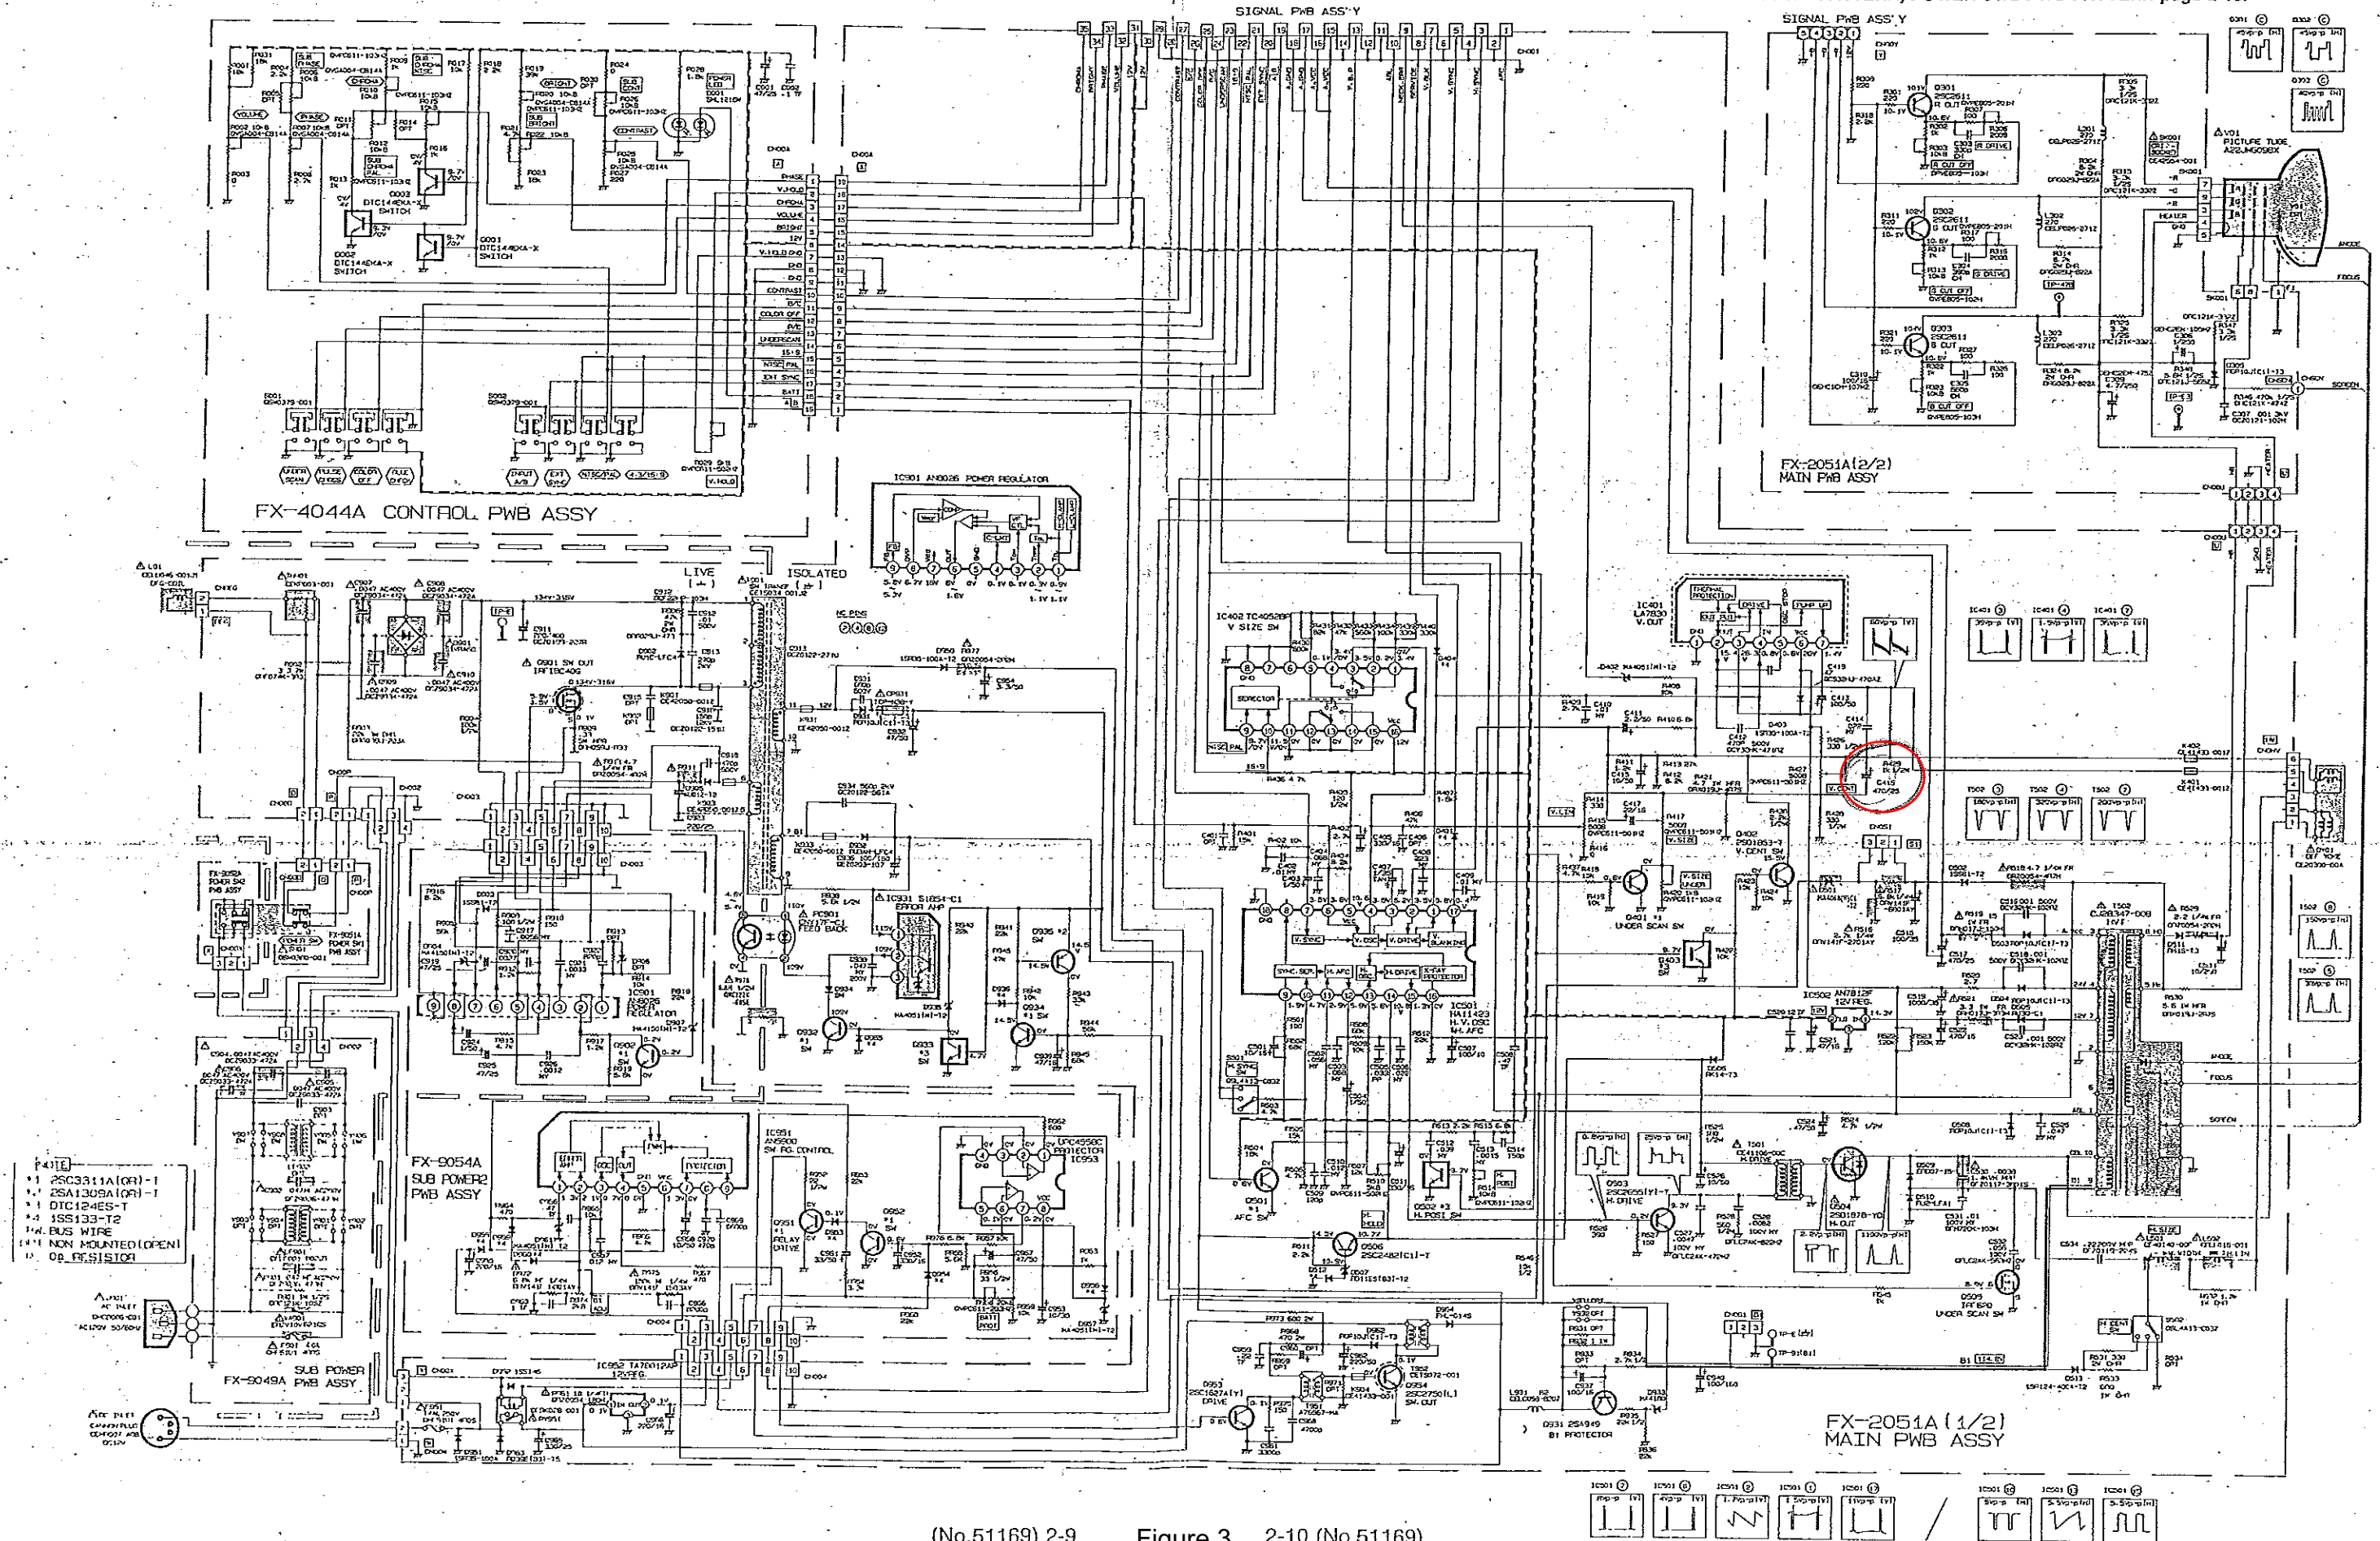
(No.51169) 2-9 Figure 3 2-10 (No.51169)

Capacitor C416 on the Main PWB may breakdown, causing a vertical deflection failure and loss of picture. The capacitor has reached the end of its life and must be replaced.

1. The exploded view diagram (Fig. 1) will show the location of the Main PWB, which must be removed for access to C416.
2. Remove C416. Refer to Fig. 2 for location.
3. Replace C416 with a new capacitor.
