SE-79HD System Expander

Loss of vertical sync in video in the LCD Viewfinder

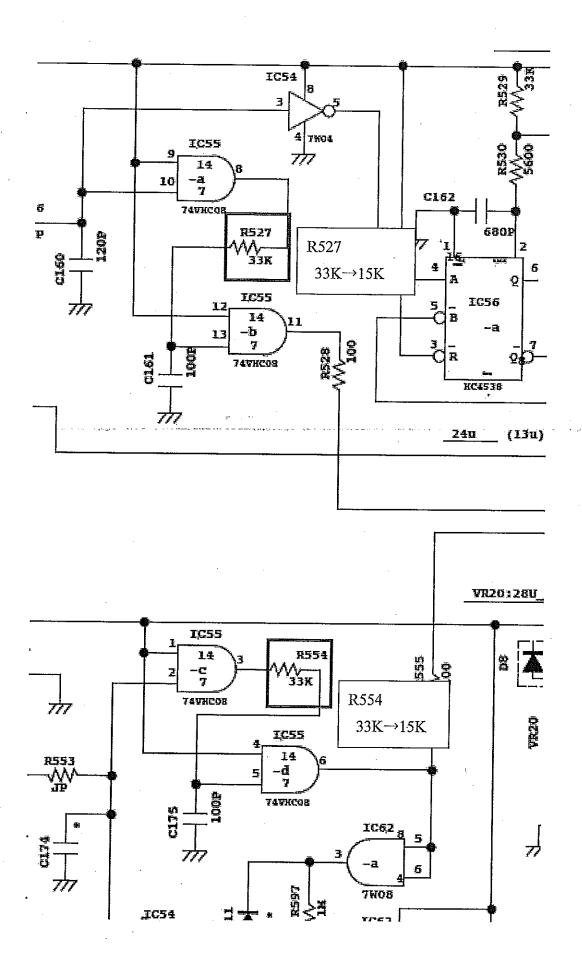
Fig 2

To upgrade the SE-79D System Expander to accept all formats, a new multi-format Video Board is installed. Occasionally, a problem can occur where vertical sync is lost in the VF video, resulting in an unstable, rolling image. This problem occurs only in the multi-format video board with PCB # PE6411E. To correct this problem, two resistors, R527 (33K ohm) and R554 (33K ohm) will need to be changed to 15K ohm values.

- 1. Remove the video board. It is located in the rear of the system expander, on the left side behind the panel with the VF aspect control and tally light. Loosen three screws to remove this panel. (Refer to Fig. 1, control location 12, for panel location).
- 2. Remove resistors R527 and R554. Refer to Fig. 2 for their location.
- 3. Replace with 15K ohm resistors.

Resistor, 15K ohm, P/N RGC1/16C 153D
