IKEGAMI TECHNICAL

BULLETIN

Ref No: 1088
Date: 11-21-03
Engineer: S. Miyatake/D. Disinger
Page: 1 of 2

Product: BS-366

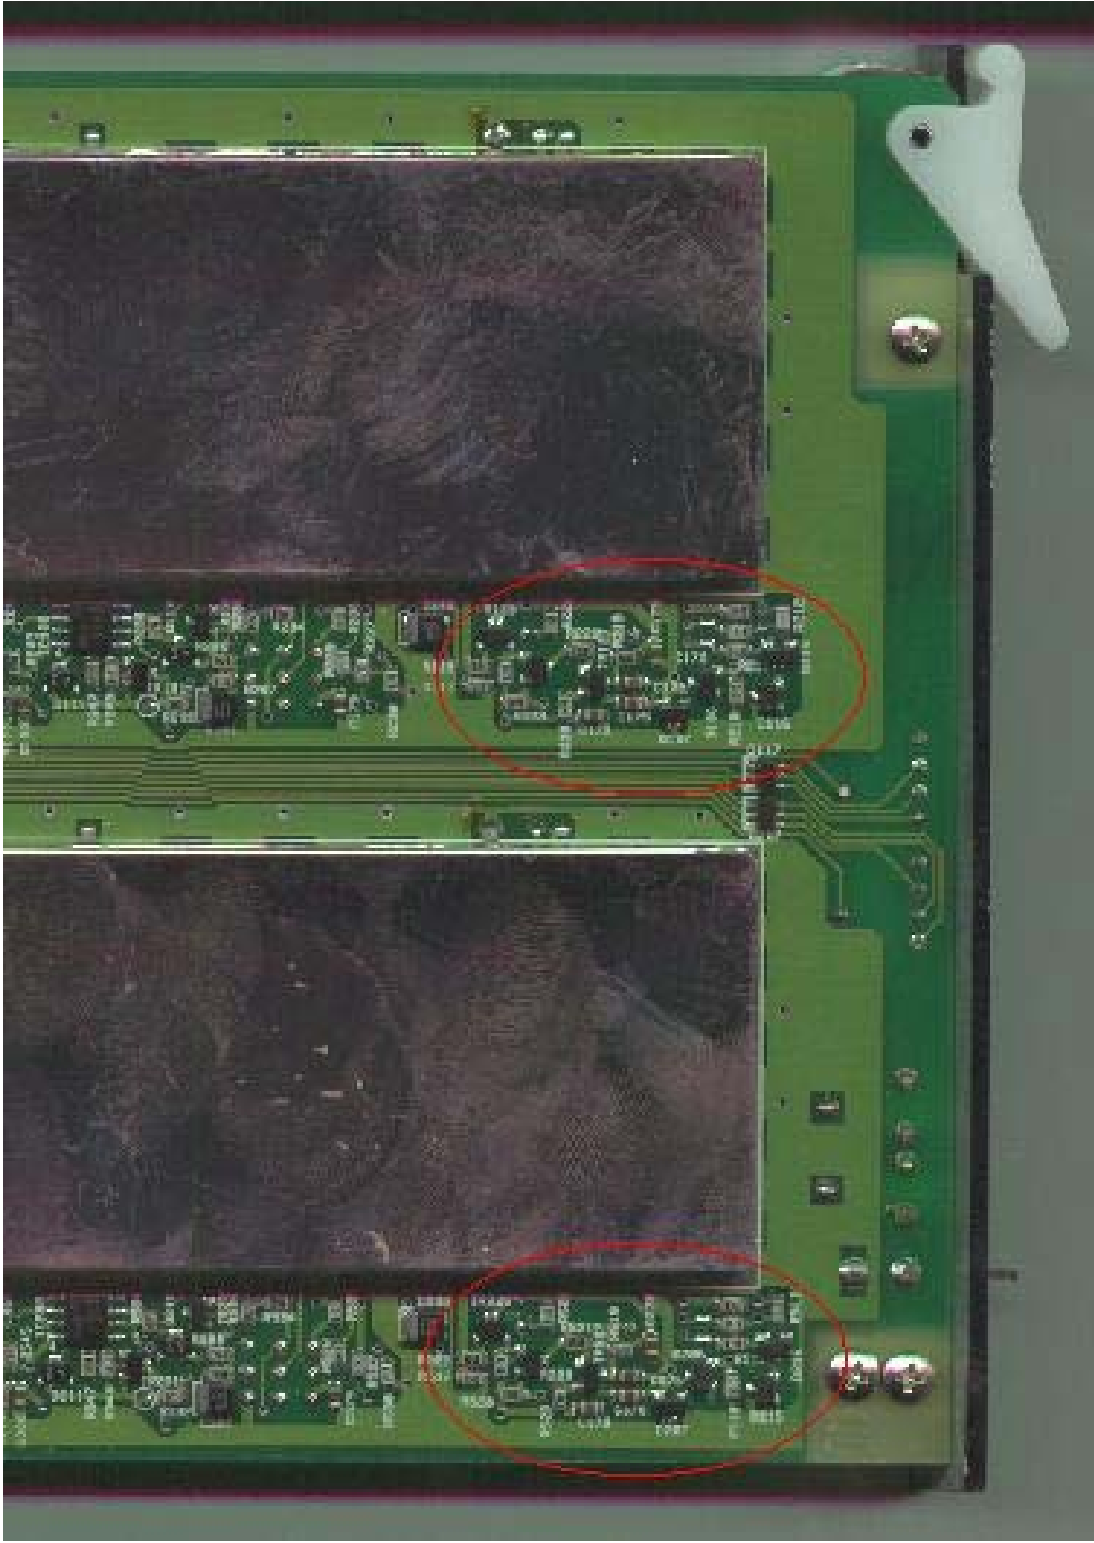
It has been found that after a long period of time in service, dust accumulation on certain components can lead to a premature failure of those components. Therefore it is recommended to periodically clean the G/Ret Video and R/B Video boards of the BS -366 to remove accumulated dust. This cleaning can be performed with a dry low-pressure air source or a very soft brush. Care must be exercised not to inadvertently remove components. See the accompanying figures for the areas of concern.
