IKEGAMI TECHNICAL

# BULLETIN

Ref No: 1088  
Date: 11-21-03  
Engineer: S. Miyatake/D. Disinger  
Page: 1 of 2

**Product:** BS-366

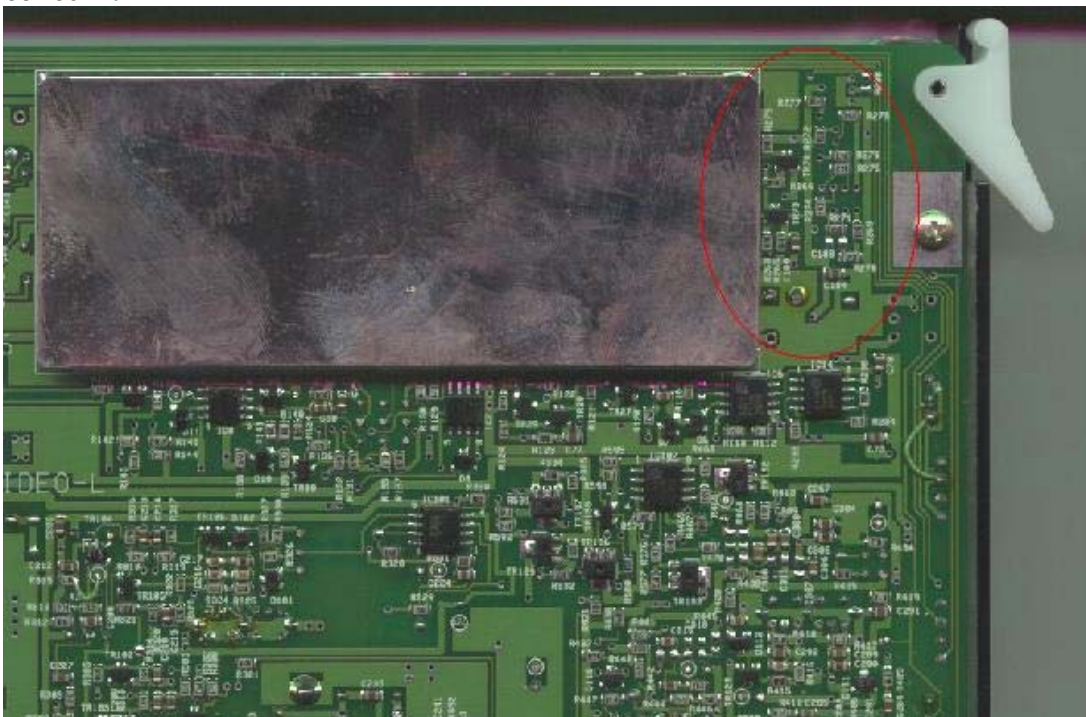
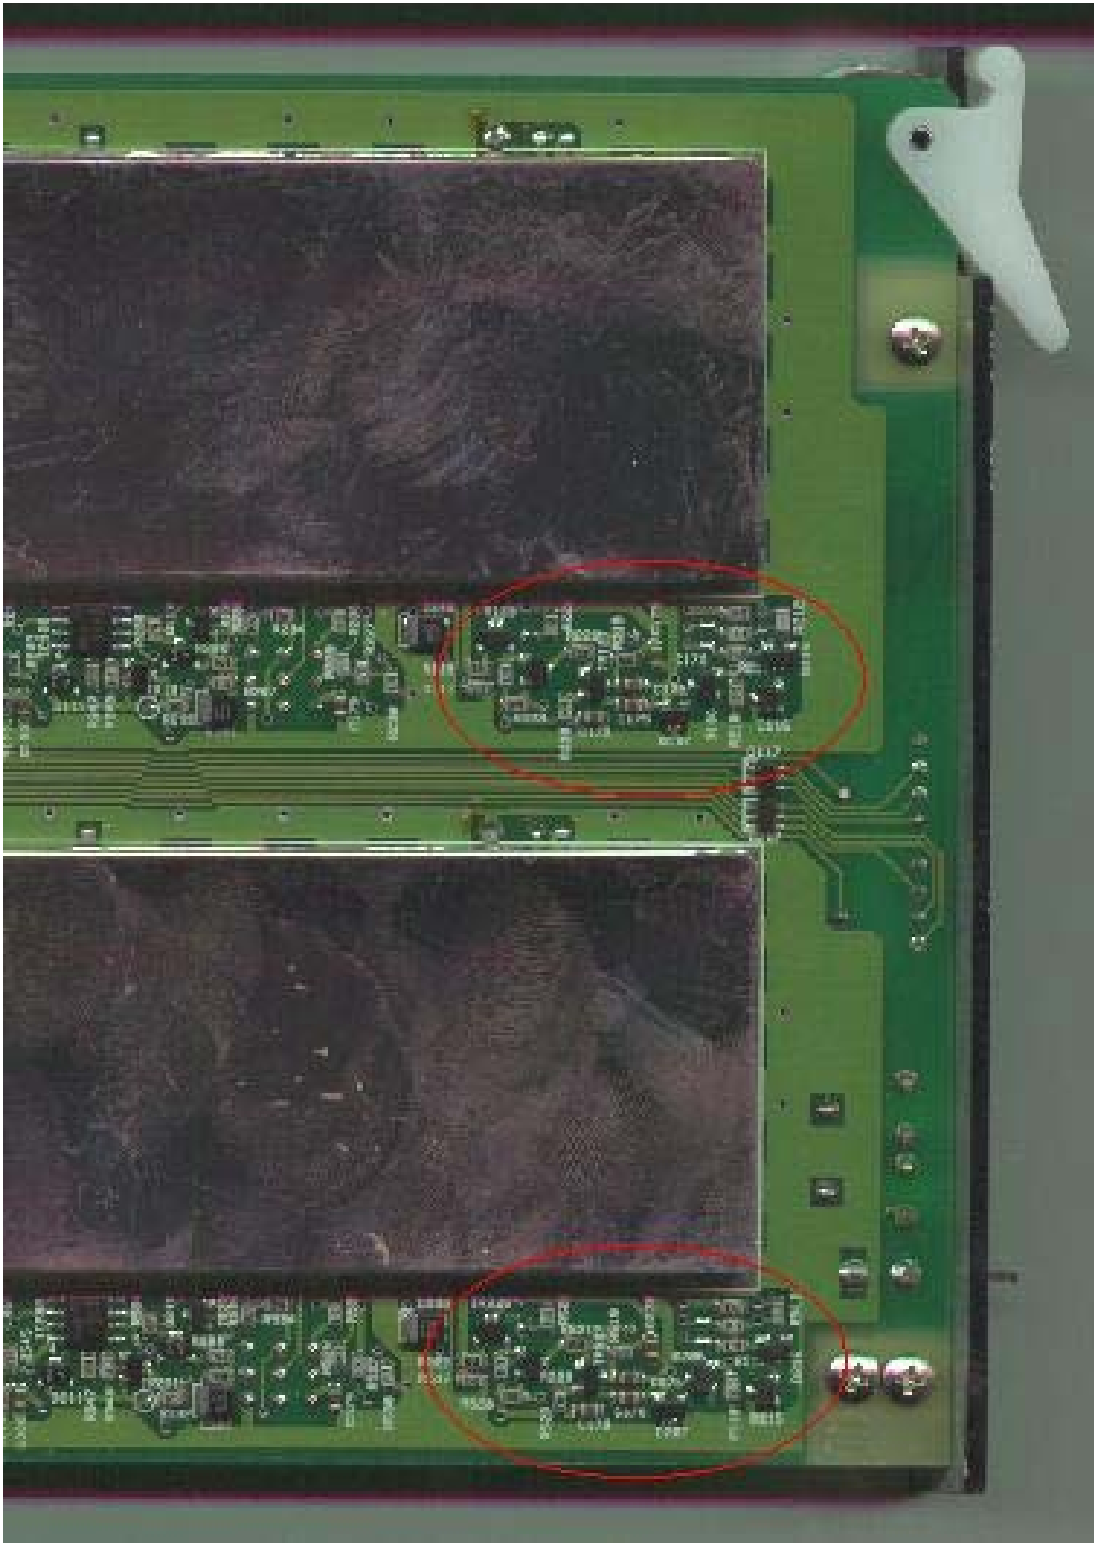
**It has been found that after a long period of time in service, dust accumulation on certain components can lead to a premature failure of those components. Therefore it is recommended to periodically clean the G/Ret Video and R/B Video boards of the BS -366 to remove accumulated dust. This cleaning can be performed with a dry low-pressure air source or a very soft brush. Care must be exercised not to inadvertently remove components. See the accompanying figures for the areas of concern.**
